ENVIRONMENTAL EVALUATION OF MINES DEVELOPMENT, INC. URANIUM AND VANADIUM MILLING OPERATIONS AT EDGEMONT, SOUTH DAKOTA

ENVIRONMENTAL PROTECTION AGENCY

APRIL 1973

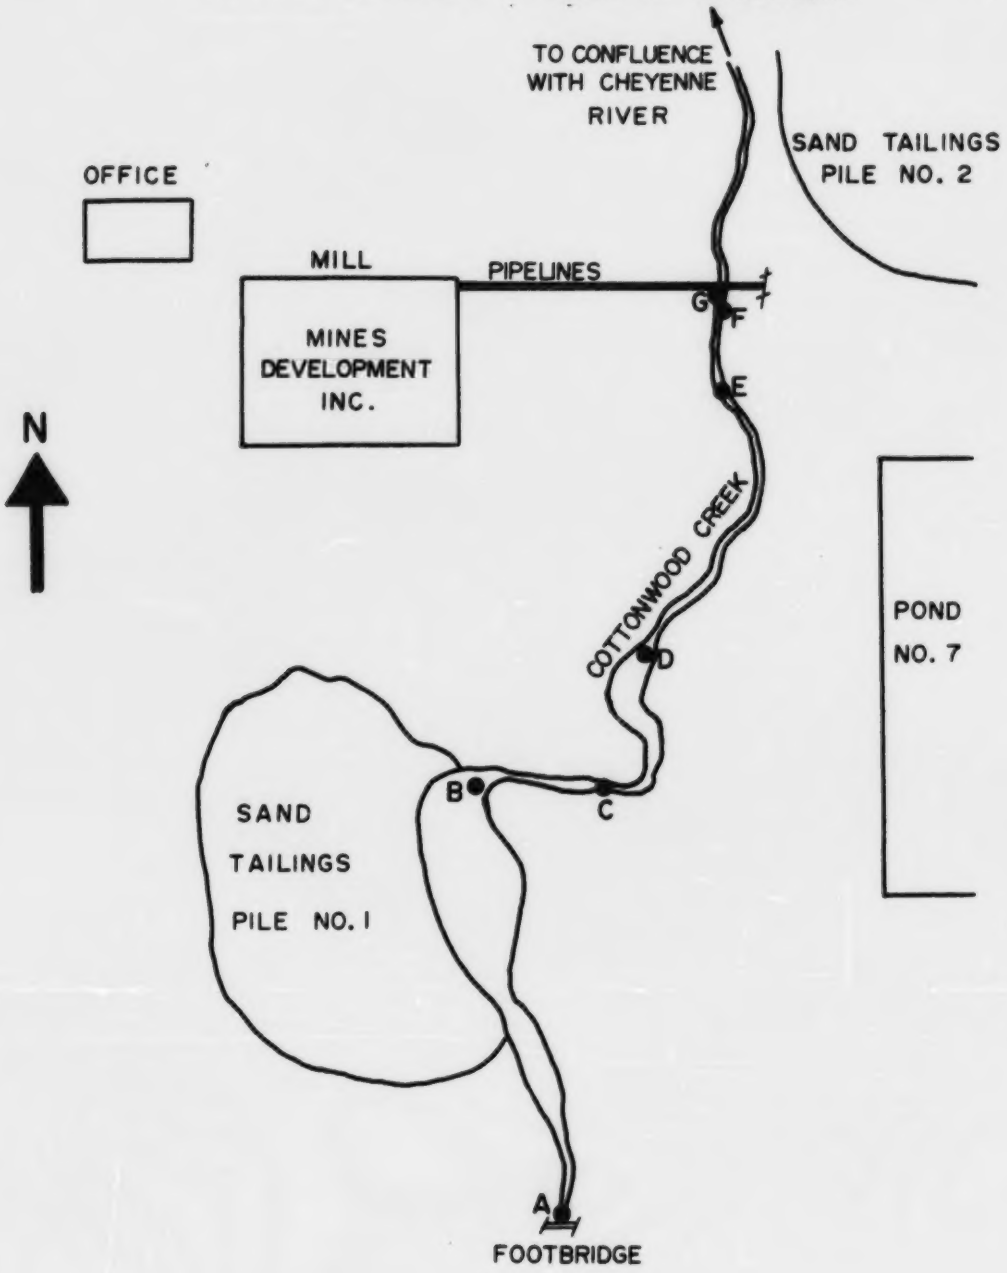
FIGURE III

As was the case in previous studies, the sediment sample collected at the pedestrian bridge across Cottonwood Creek (Station A) contained radium-226 at a concentration slightly greater than the background level. The possible explanations are a natural source (spring flow) or periodic contamination of the site by windblown sand tailings from pile No. 1 (located several hundred feet downstream). Since the sediment was stained at this

COTTONWOOD CREEK
BOTTOM SEDIMENT SAMPLING STATIONS

The field study eliminated any question regarding the transport of sand tailings from pile No. 1 into Cottonwood Creek by errosive action during periods of high runoff and/or wind action. Such transport was documented by the analysis of bottom sediment samples as well as visual observation of the common boundary between the creek and the tailings pile for a distance of several hundred feet. One small section of this common boundary is shown in Figure IV (photograph taken on October 3, 1972-low flow condition). Similar documentation was obtained for the loss of sand tailings from the Pond No. 2 storage area. Soil samples collected at thirteen locations on the Cheyenne River bank and the dry stream bed adjacent to Pond No. 2 (Figure V) showed that sand tailings had breached the security fence and were beginning to migrate down the slope. Radium-226 concentrations in samples collected just outside the fence - Stations S1, S2, S3, and S4 - were indicative of sample compositions approaching 25 to 50% sand tailings (Table X). Along the line marking the sharp increase in bank slope - Stations S5, S6, S7, S8, and S9 - background concentrations of radium-226 were found. These data suggested that a loss of solids to the river had and continues to take place, but the magnitude of the loss has not been large. Slightly elevated radium-226 concentrations in the dry stream bed - Stations S11 and S12 - were probably caused by seepage as opposed to sand tailings.
